Appendix F

Structures Visual Inspection Forms

FACILITIES CONDITION ASSESSMENT REPORT

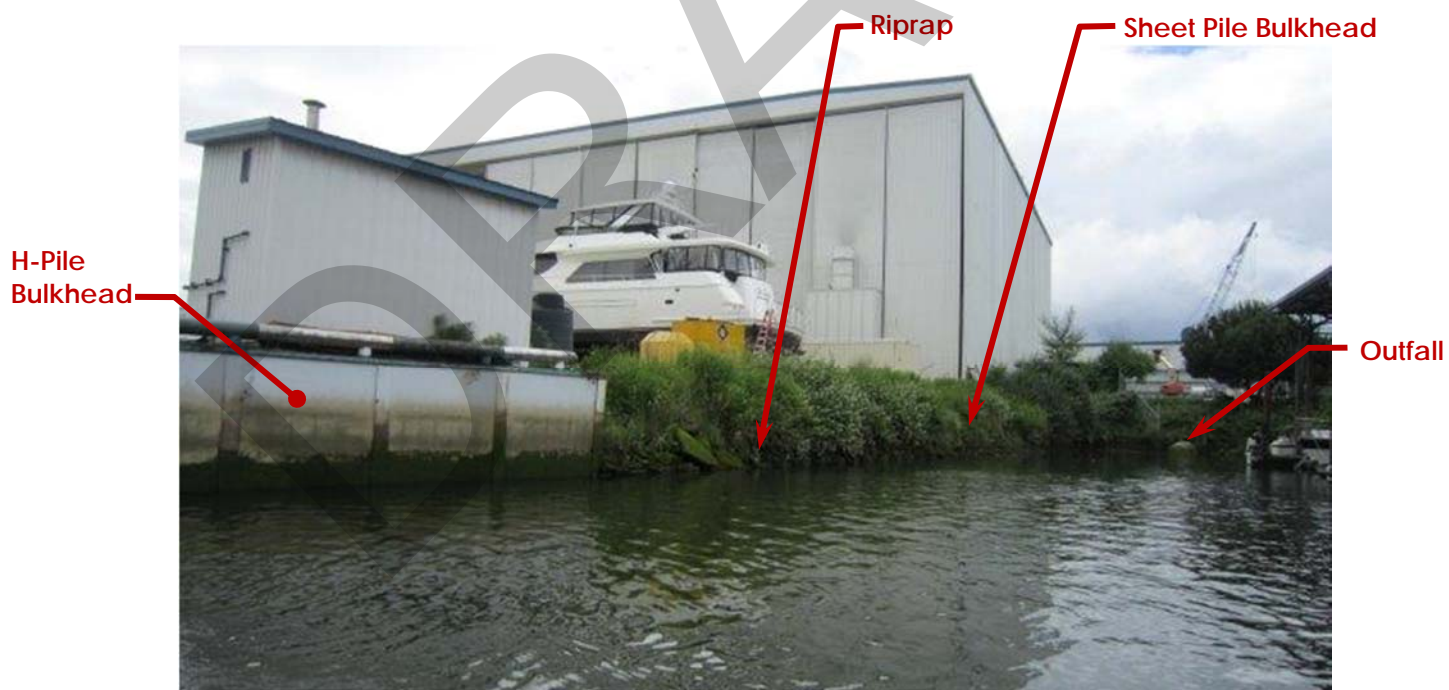
Photo ST12-014: Upstream North Bulkhead

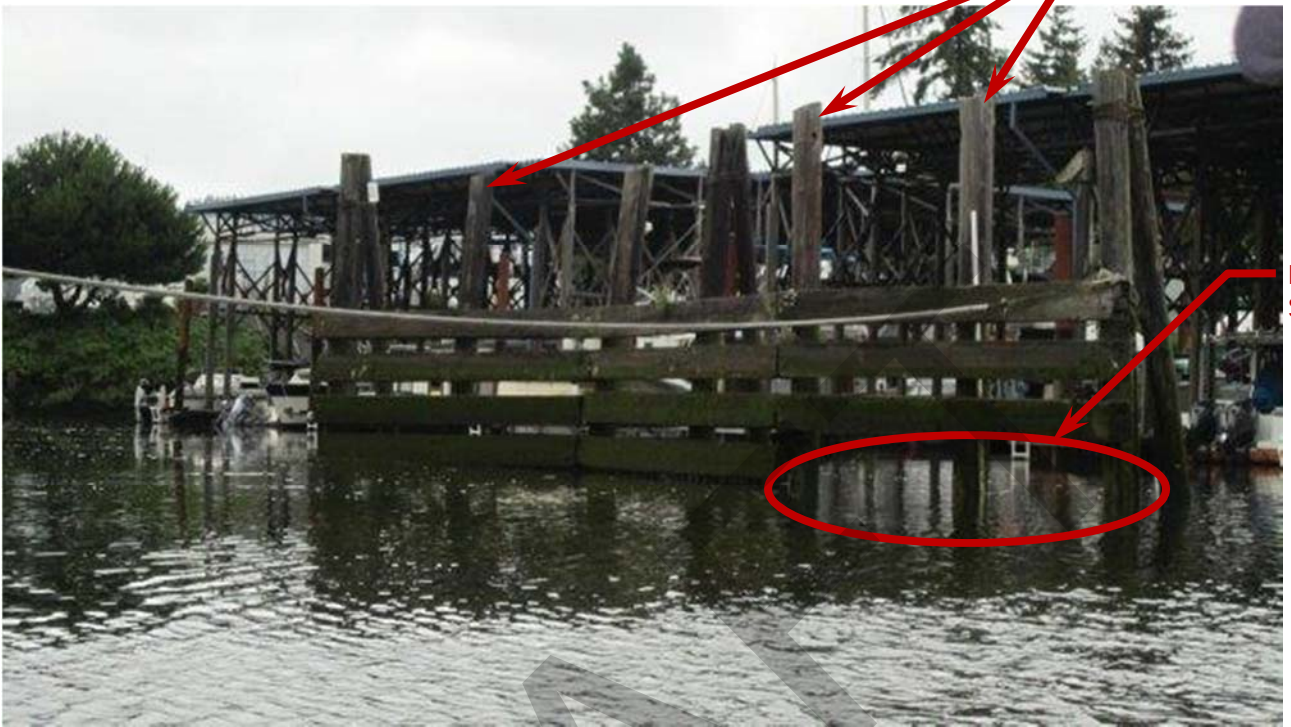
Photo ST13-01: Breakwater (Looking Northwest)

- Seven (7) sets of vertical and battered (toward the north) timber piles and horizontal timber slats (Photos 1 to 3).
- The piles appear to be in good condition, except several battered piles and slats are missing (Photos 1 and 2).
- Members are covered with moss within the tidal zone.
- Wood treatment is worn, but appears to be in good condition (Photo 3).

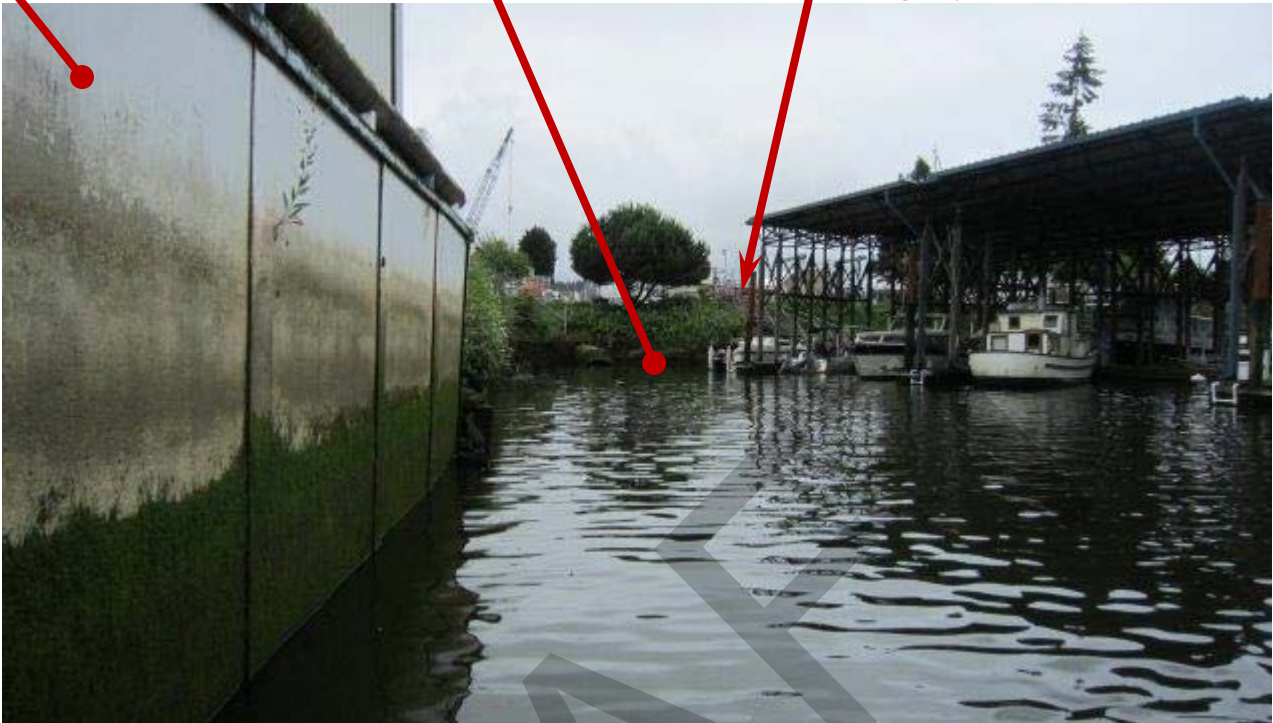
Photo ST15-01: South-most Float (Looking West)

- Concrete bulkhead along the west bank (Photo 1). The bulkhead was not accessible, therefore not observed.
- Four (4) gangways leading to the floats (Photos 1 and 2). The gangway was not accessed, therefore not observed.
- Four (4) parallel covered docks each with connection primary floating walkways.
- Timber float guide piles.

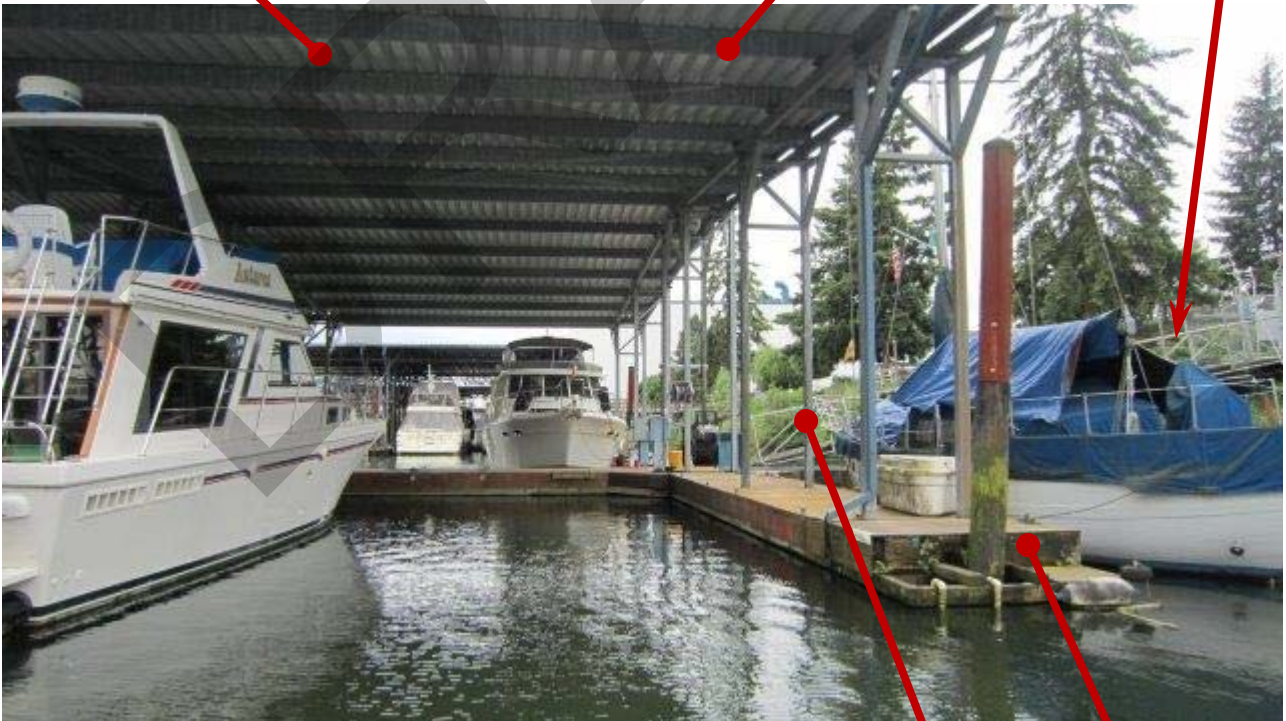
Photo ST15-02: Floats (Looking South)

- The guide piles are timber piles with a steel sleeve filled to the upper section (Photos 2 to 4, 6 and 7).
- The guide piles are covered in moss around the tidal zone but appear to be in good condition (Photos 2 to 7).
- The preservative treatment on the piles are worn but appear to be in good condition (Photos 2 to 7).

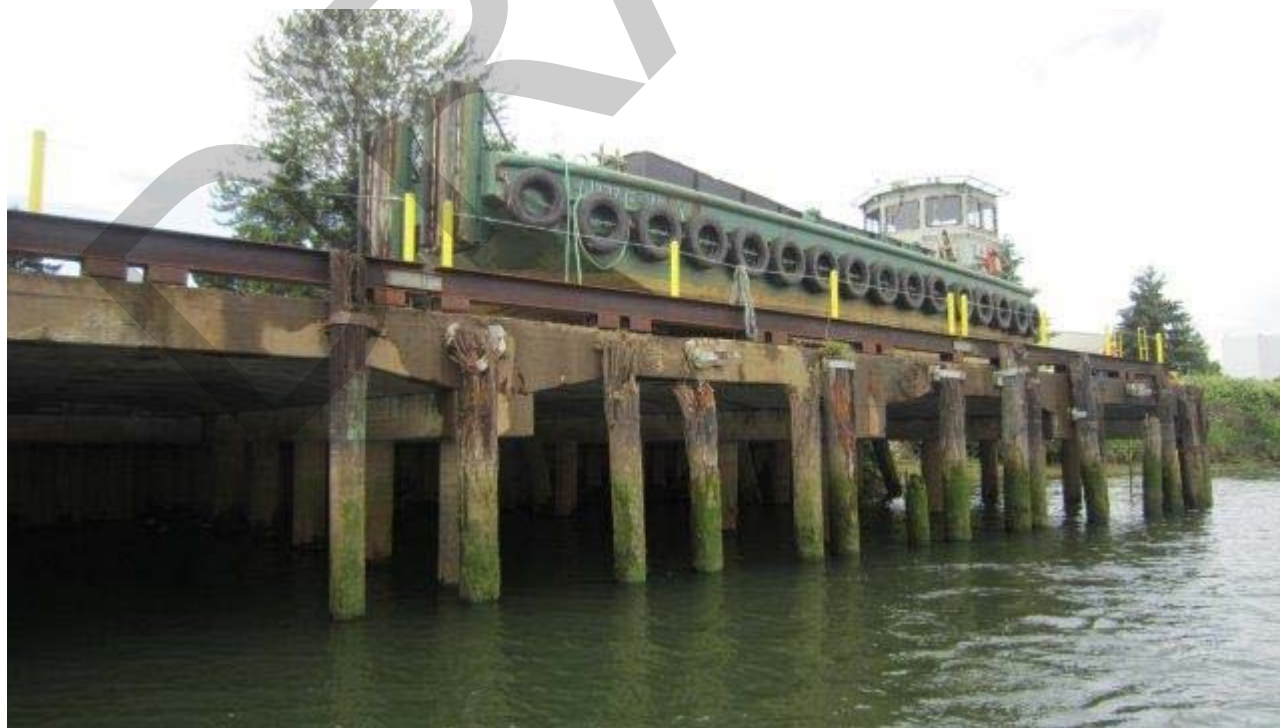
Photo ST16-02: Piers 2 to 4 (Looking Northwest)

- Majority of the fender piles are missing, broken, damaged, or in poor condition. Most pile straps are either missing or broken (Photos 2 to 5).

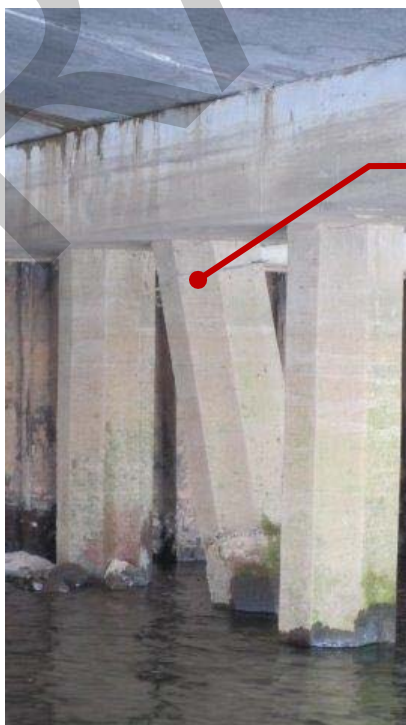
Photo ST16-06: Concrete Piles

- The concrete piles appear to be in good condition except surface mortar erosion and moss growth in the wet/dry zone of the piles (Photos 6 and 7).
- There is a significant loss of concrete on the south face of the pile at Bent 4, Row 2. No exposed reinforcing or rust stains were observed (Photo 8).
- Approximately 12-in of the pile at Bent 2, Row 4 appears to be field built-up (Photo 9).

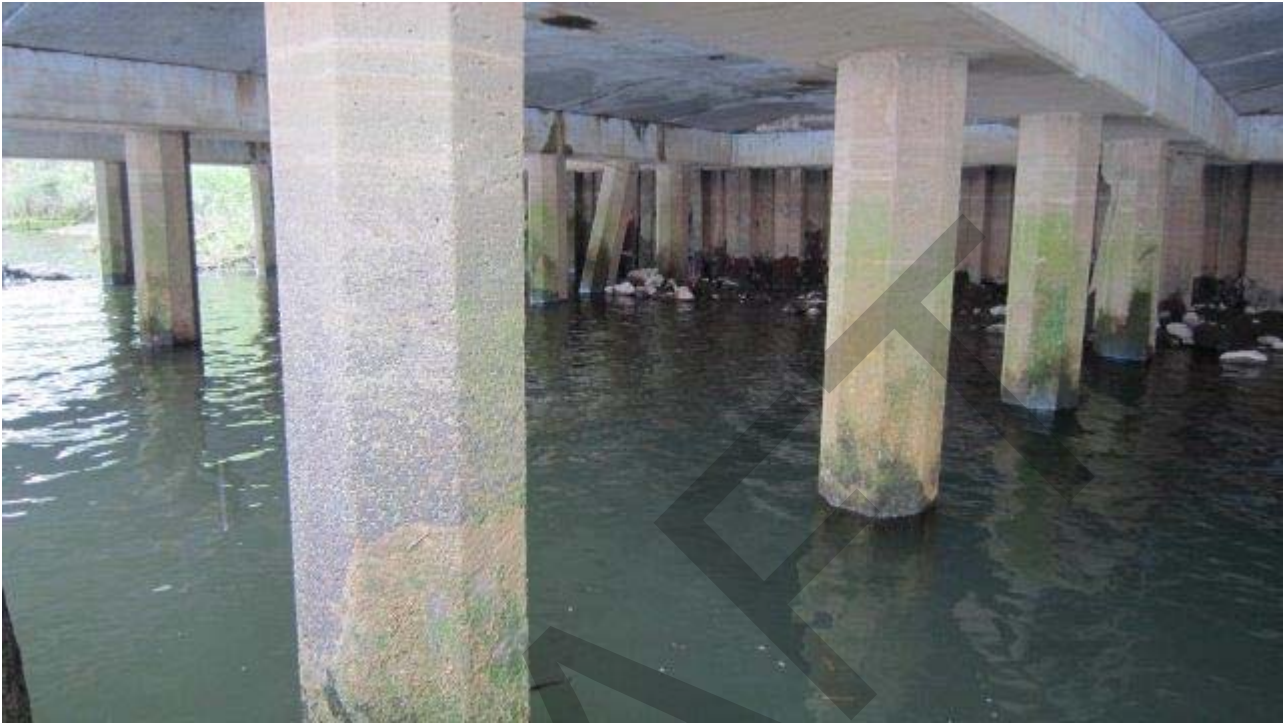
Photo ST16-07: Concrete Piles (Looking Southwest)

- The concrete surfaces of the pile caps appear to be in good condition. No cracks, spalls, or significant chips were observed (Photos 7 to 11).

- A close observation of the steel sheet pile and concrete cap was not possible. There appears to be moss growth and rust in the wet/dry zone of the sheet pile (Photos 7, 10, 12, 14, and 15).

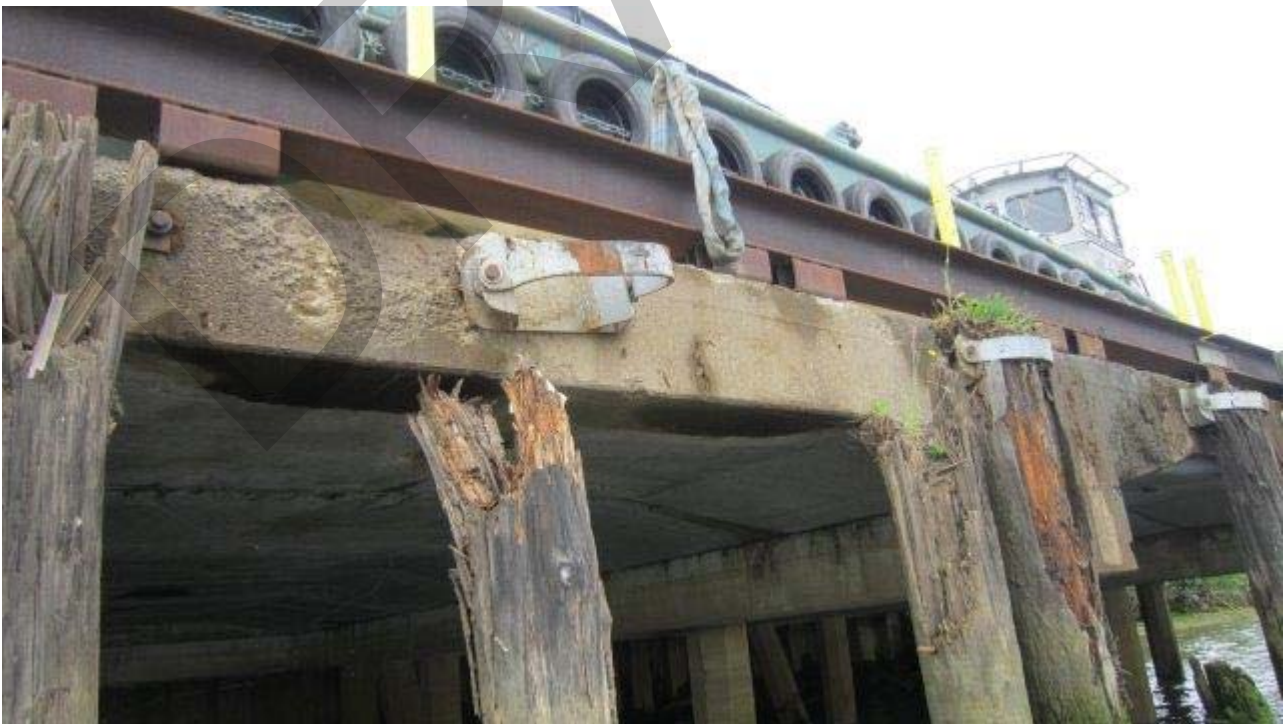
Photo ST16-12: Pier 3 Pier Deck

- Spall at the east face of both Pier 3 and Pier 4 decks. No exposed reinforcing or rust stains were observed (Photos 12 and 13).
- The concrete surface of the pier deck soffits appear to be in good condition (Photos 14 and 16).

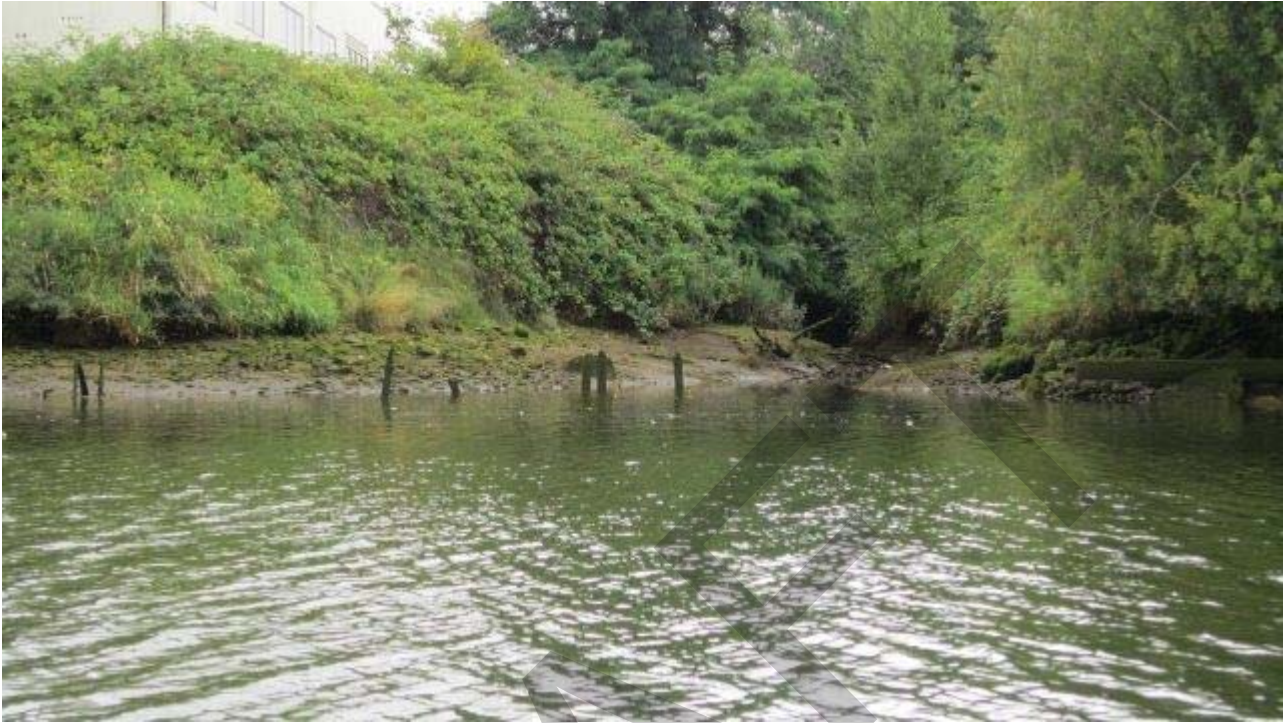
Photo ST17-01: Pile Field

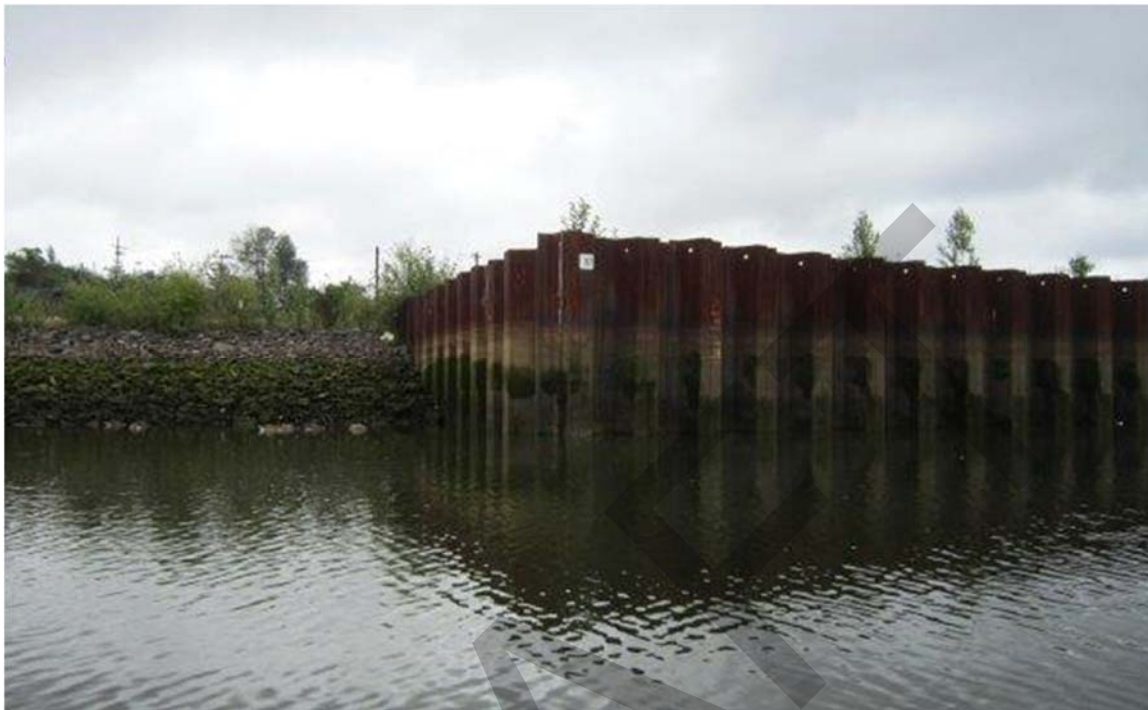
- Structure consists of U-shaped steel sheet pile bulkhead for contamination containment of Terminal 117 Cleanup Site.
- The piles appear to be in good condition. (Photos 1 to 4)
- The North and South return walls abut riprap river bank embankment. (Photos 1 to 4)
- Near the north end of the bulkhead, four (4) 12" diameter steel pipe guide piles support for a 16" diameter float debris deflection pile pipe. The piles and float are in good condition. (Photos 2 and 3)

Photo ST19-01: South Return Wall (Looking Northwest)

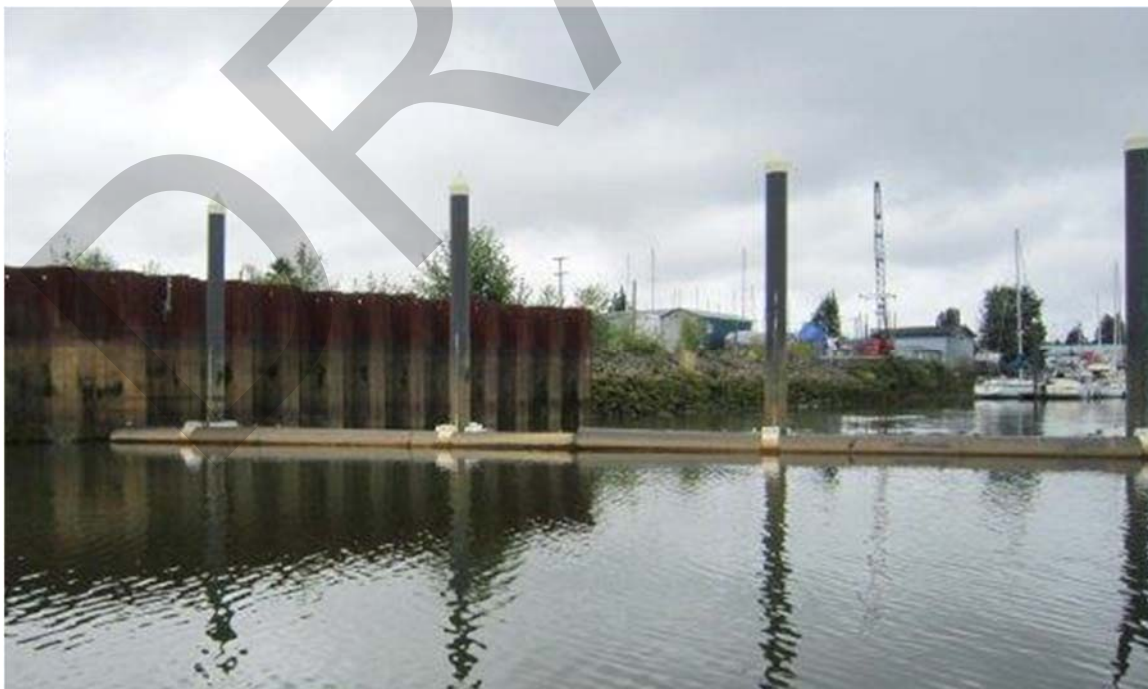
Photo ST19-02: Debris Deflector Float (Looking Northwest)

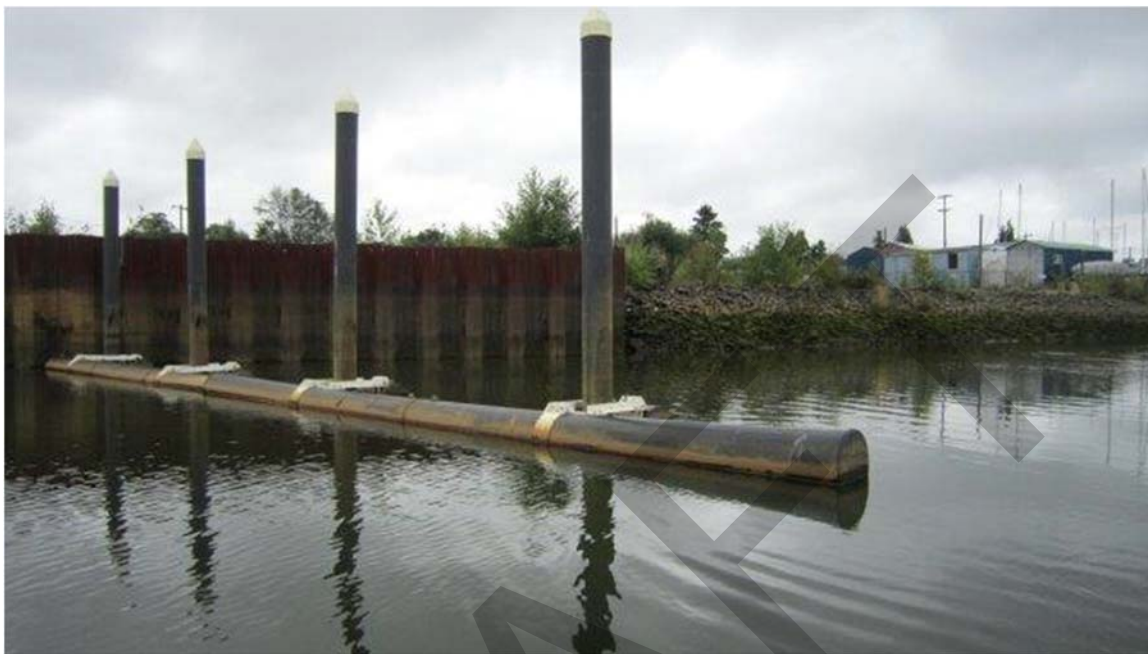
Photo ST19-03: Debris Deflector Float (Looking Northwest)

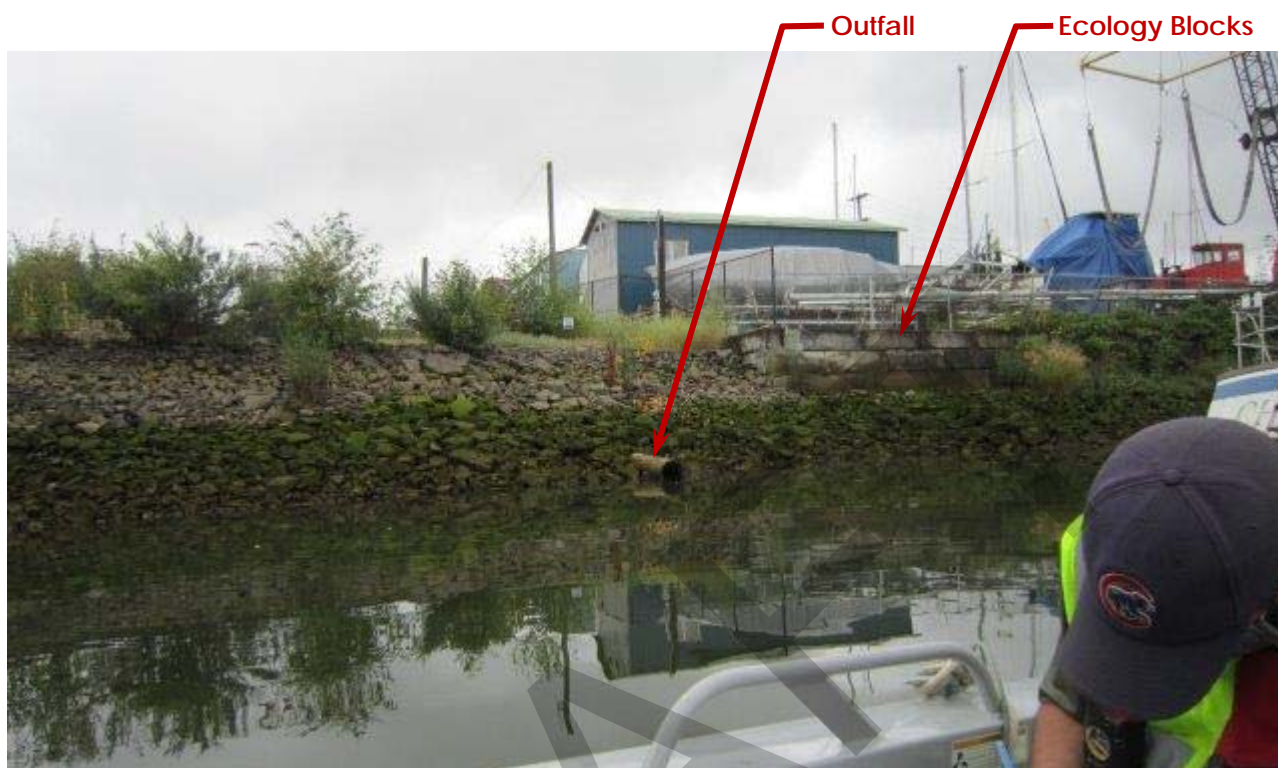
Photo ST20-01: Retaining Wall Bulkhead (Looking Northwest)

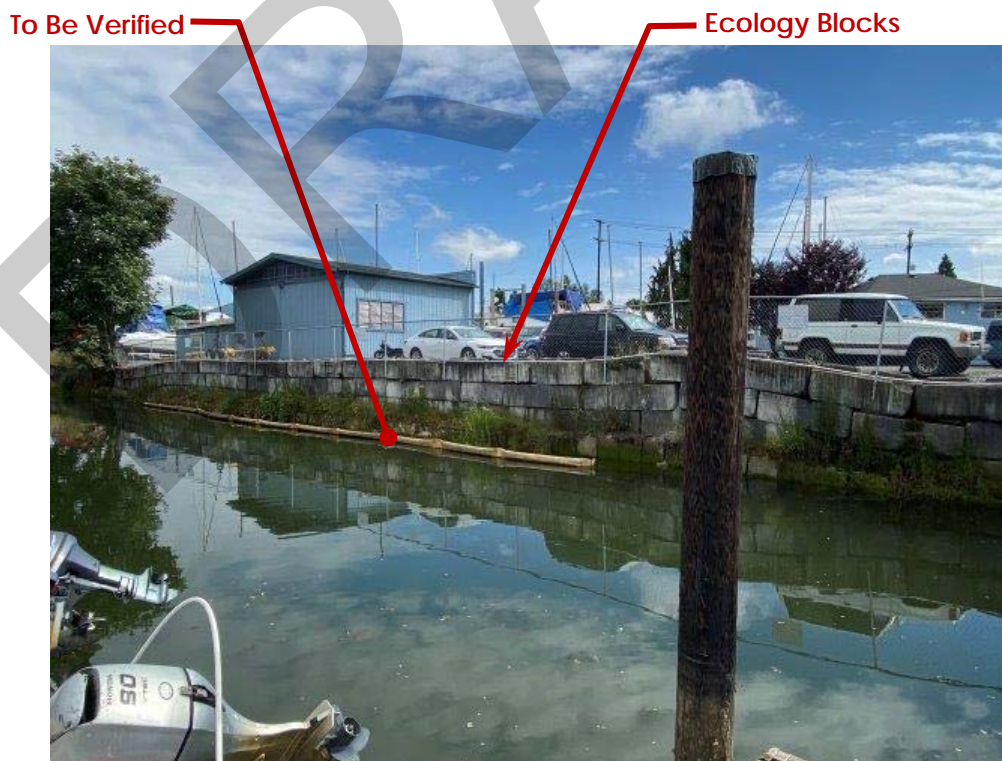
Photo ST20-02: Retaining Wall Bulkhead (Looking South West)

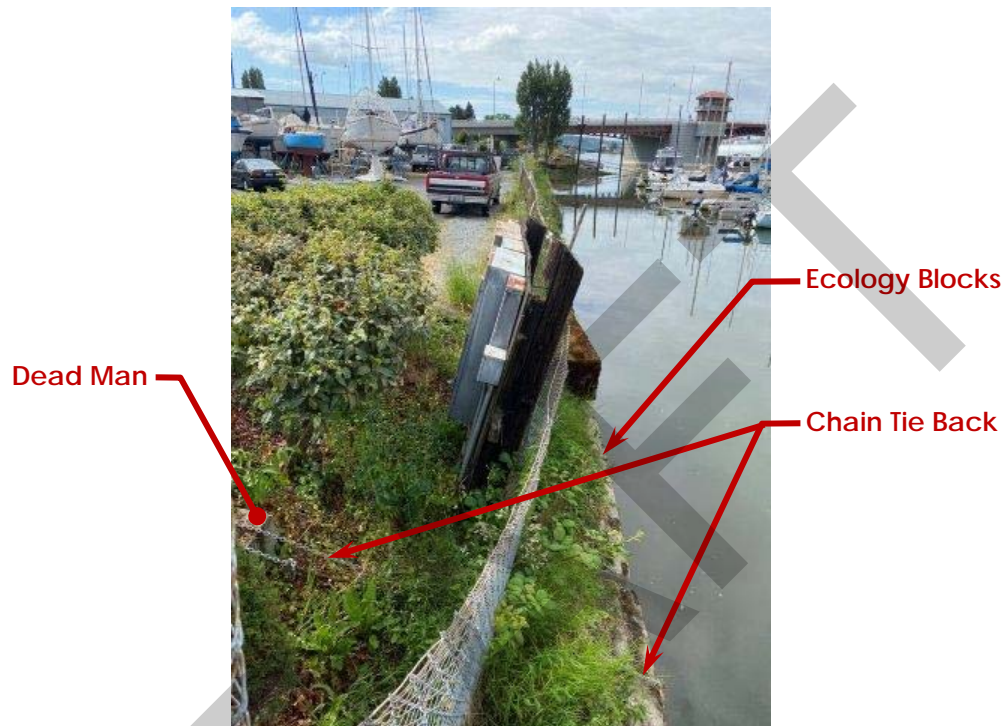
Photo ST20-03: Retaining Wall Bulkhead (Looking North)

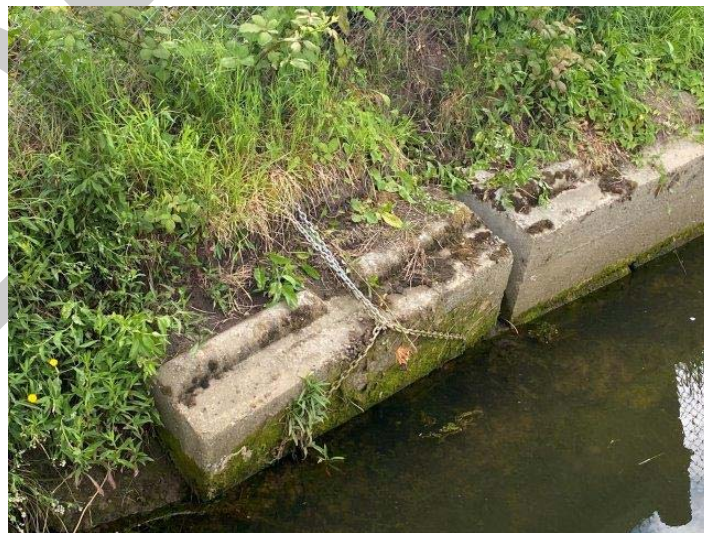
Photo ST20-04: Close Up of Chain Tie Back

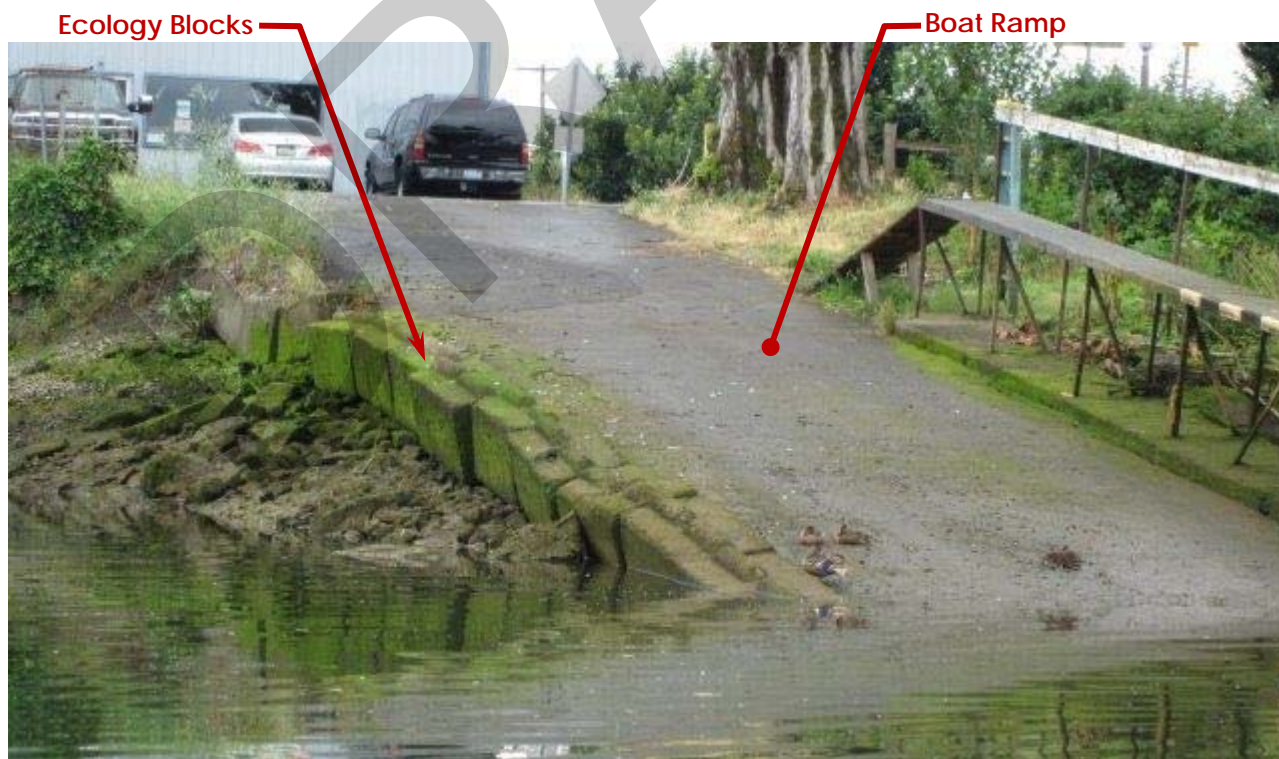
Photo ST20-06: Boat Ramp (Looking Northwest)

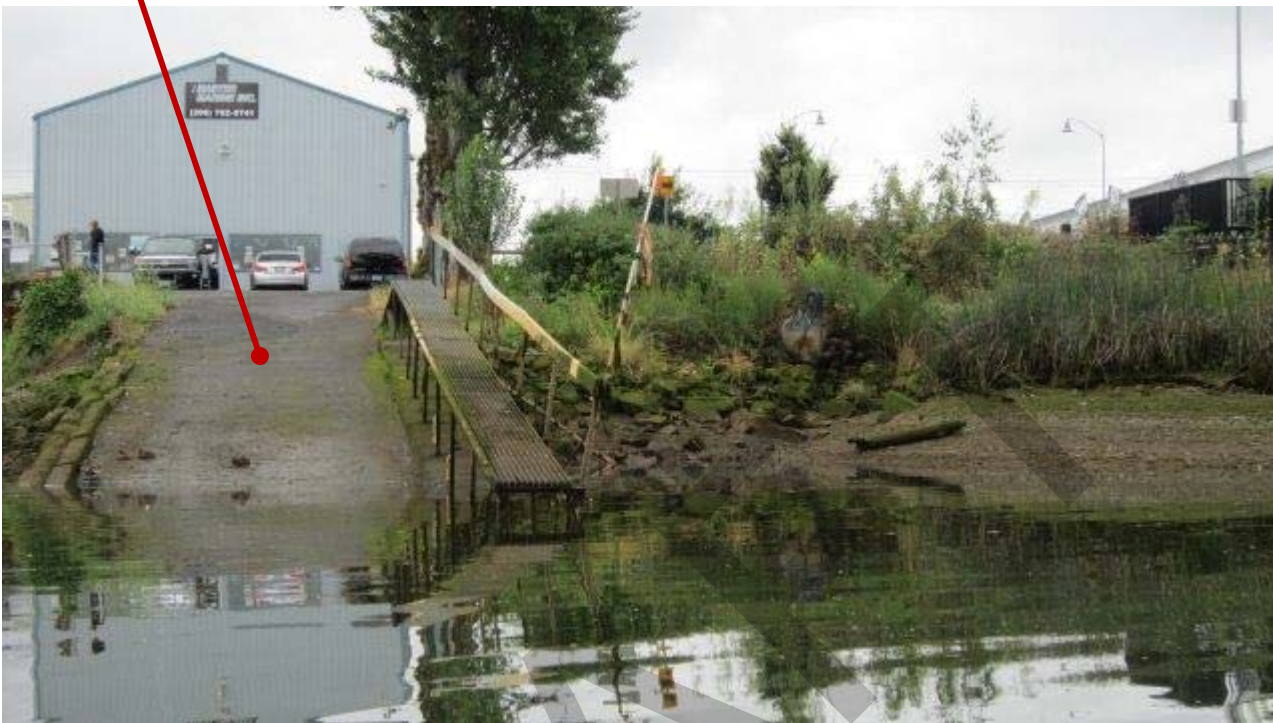
Photo ST20-07: Boat Ramp (Looking West)

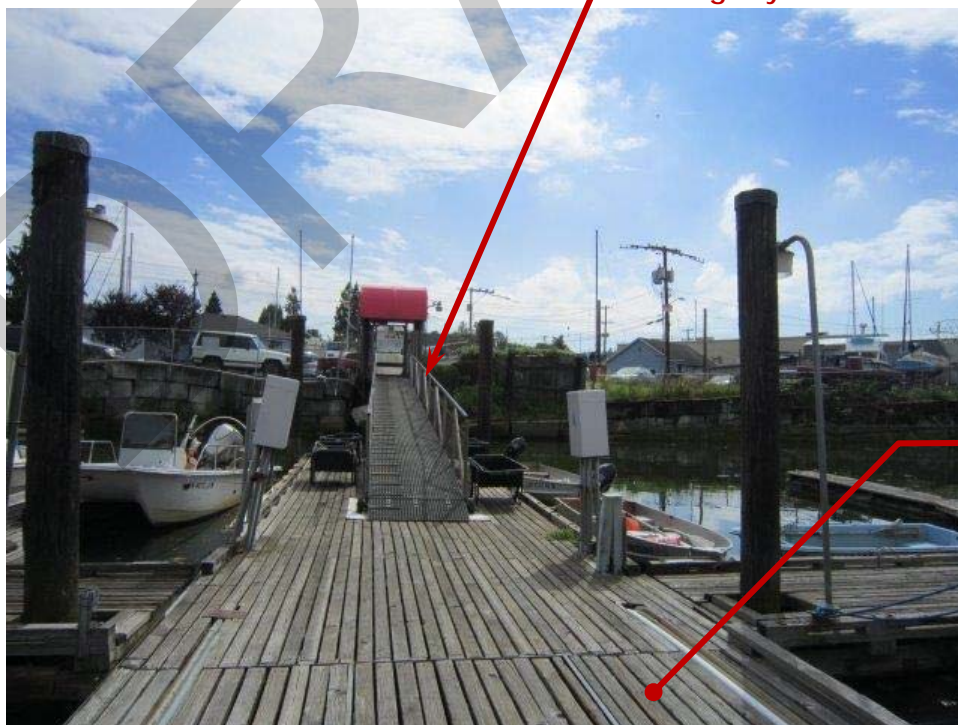
- The galvanized steel pipe truss gangway is supported on the west end but the type and condition of the support is unknown (Photo 8).
- Utilities servicing the marina are hung on the west end of the gangway and fed from under the gangway. The integrity of the pull box cantenary supports is not known (Photos 9 and 10).
- There is scattered rust along the length of the truss members and corrosion at several welded joints (Photos 9 and 10).
- The wood walkway decking is worn and weathered but not distress was observed.
- The slip resistant grating over the decking appears to be in good condition.

Photo ST20-08: Gangway and Walkway (Looking West)

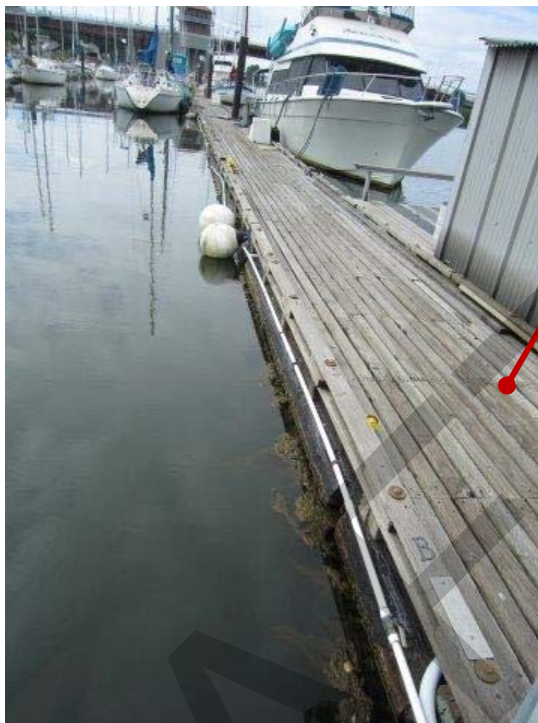
- The walkway, docks, and finger piers timber decking are worn and weathered. A number of planks appear to have been replaced, missing, re-fastened. Except for scattered dead or lost knots and checks no evidence of rot, moss growth, splinters, or perceptible deflection was observed (Photos 11 to 18).
- Utilities on the dock include power, water, and cable (Photo 13 and 14).

Photo ST20-11: Secondary Walkway (Looking North)

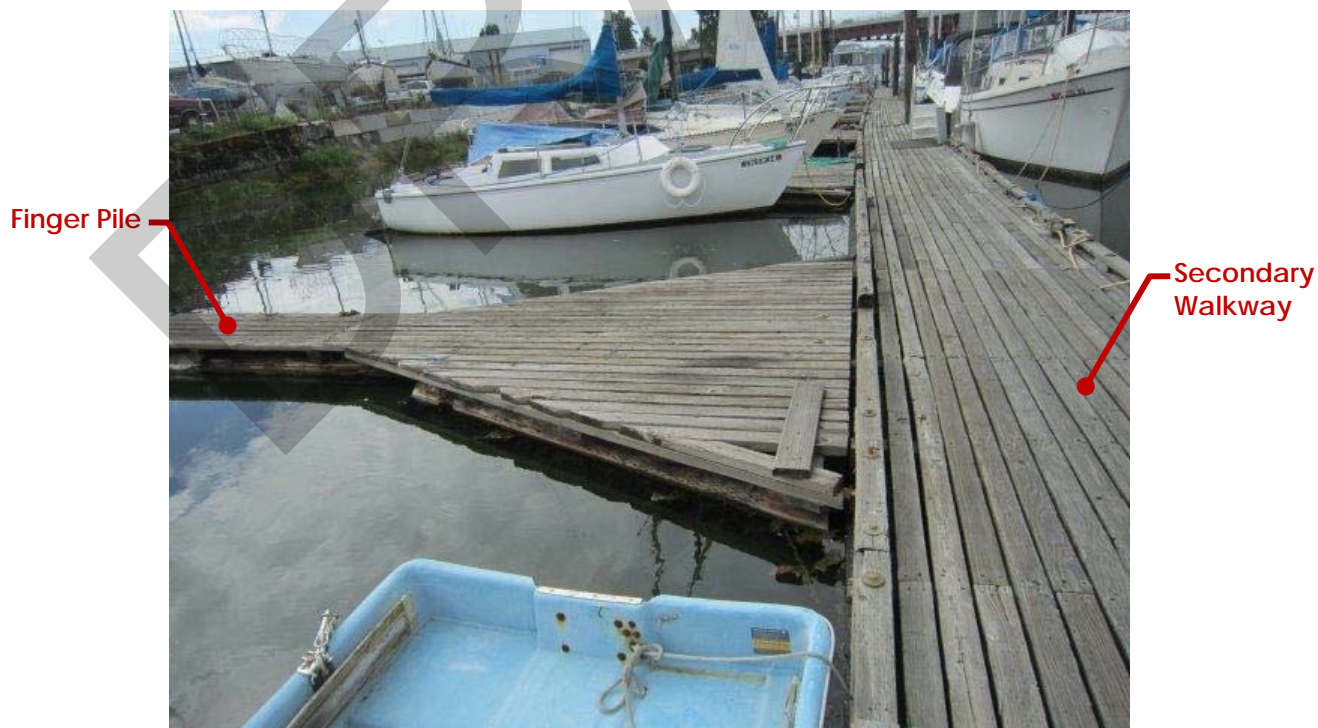
Photo ST20-12: West Secondary Walkway (Looking North)

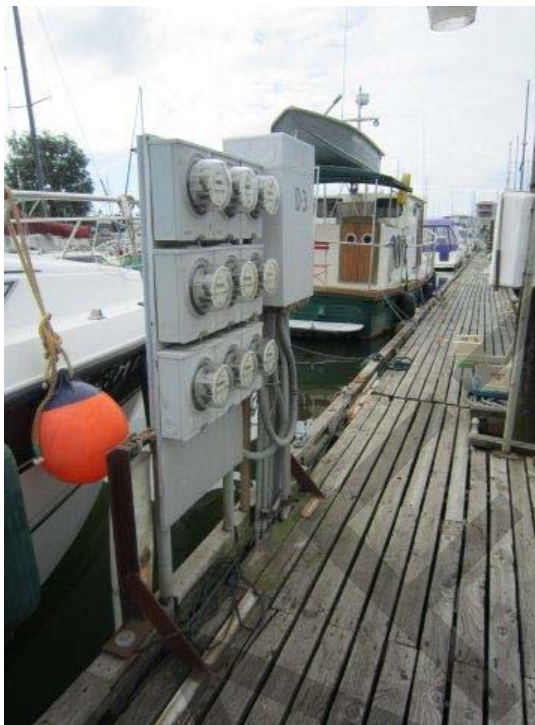
Photo ST20-13: Utilities

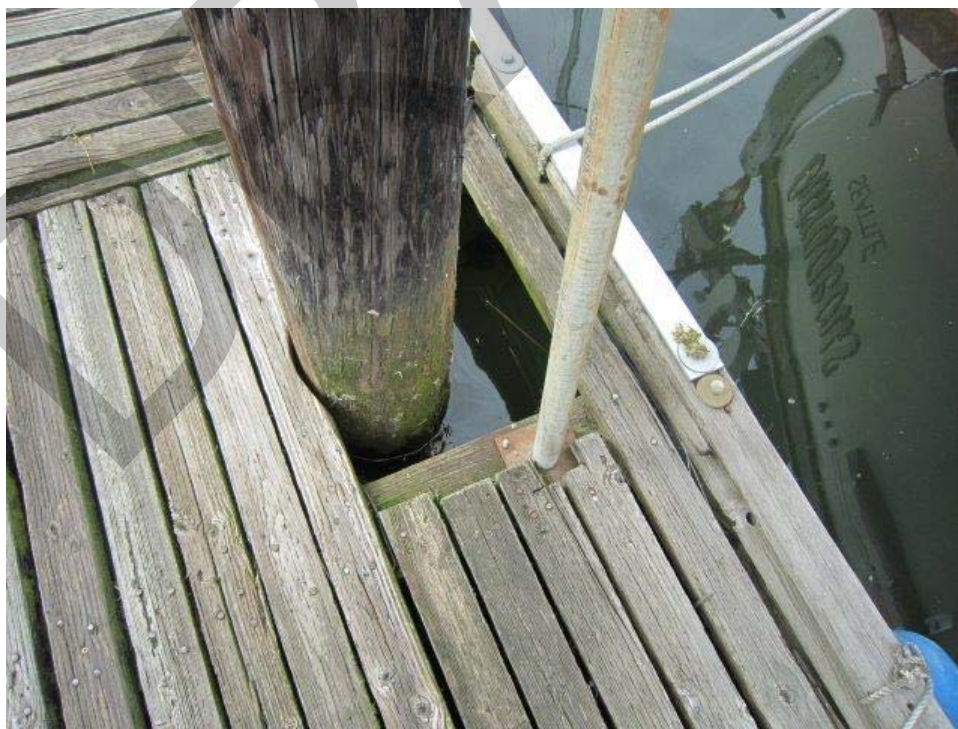
- The timber guide piles and preservative treatment appear to be sound in good condition except for moss build up around the splash zone (Photos 15 to 17).
- The steel guide piles appear to be newer than the timber piles. They are in good condition (Photo 18).
- The pile guides appear to be of different configurations. Damage consists of broken members, missing members, and abrasion (Photos 15 to 18).

Photo ST20-016: Float Guide

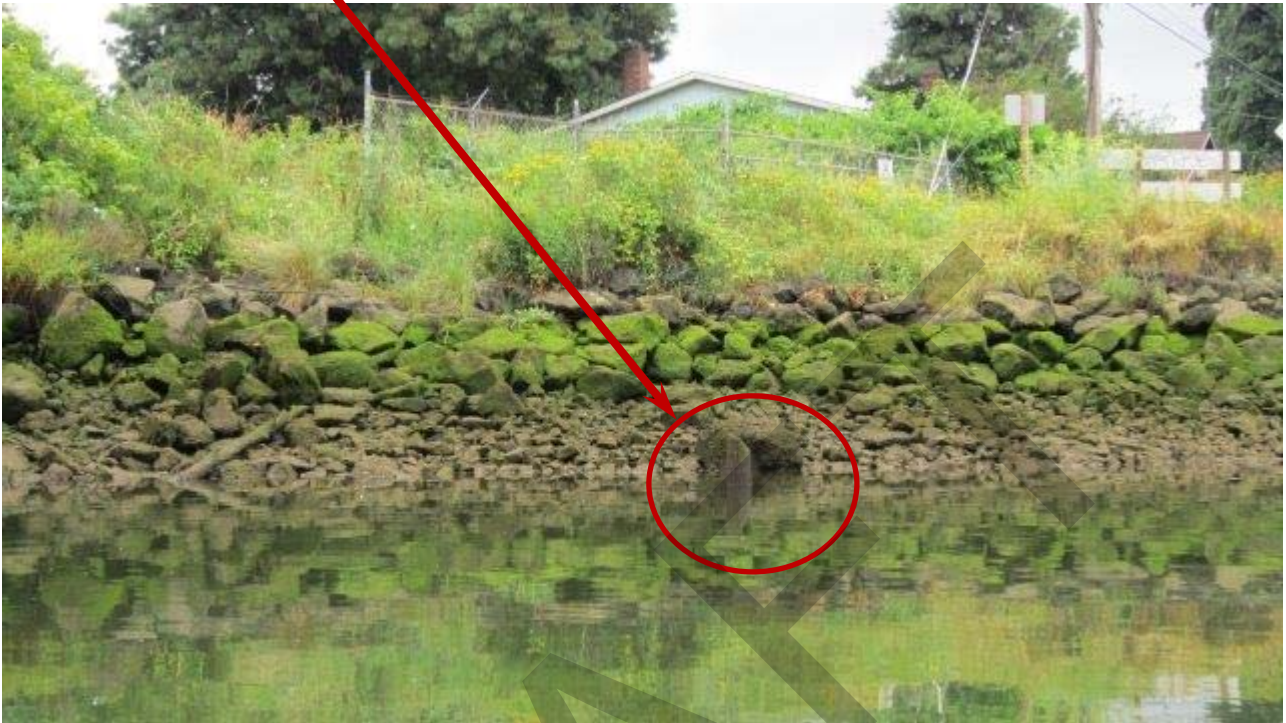
- Several scattered timber piles north of the S 98th St Bridge near the shoreline. They appear to have been cut down and are in poor condition (Photos 1 to 3).

Photo ST21-01: Southmost Pile Field

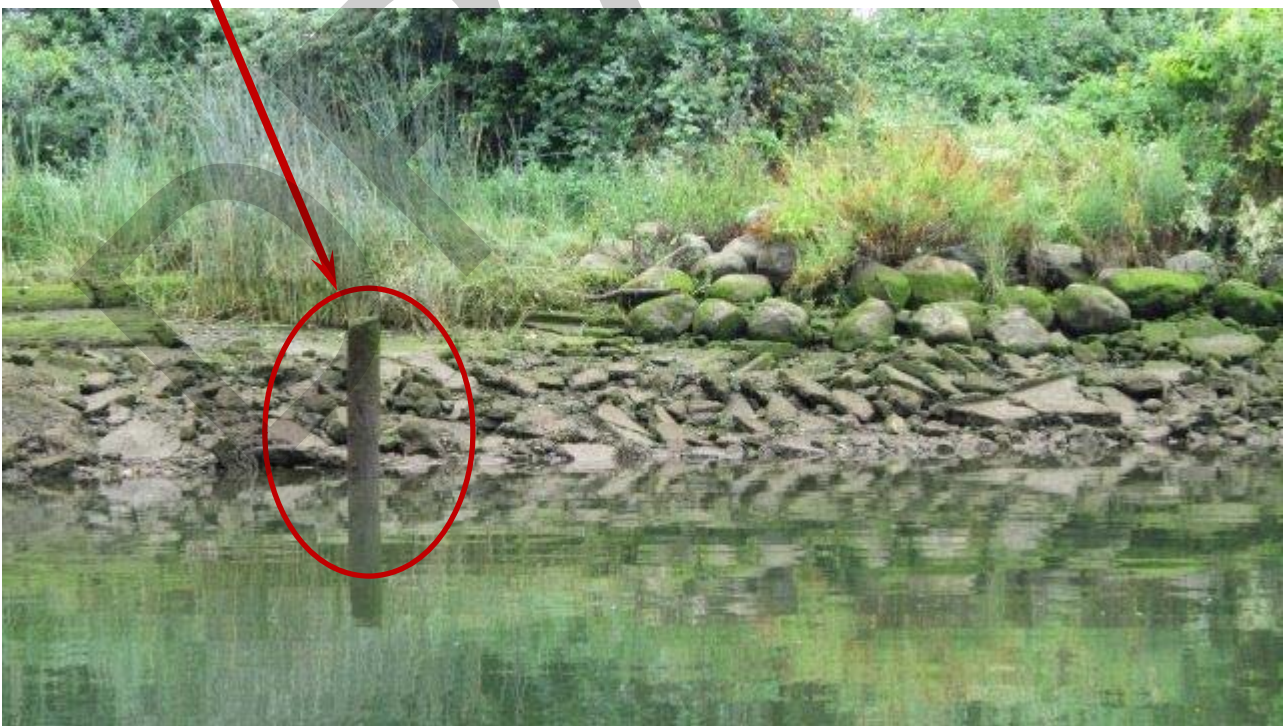
Photo ST21-02: Central Pile

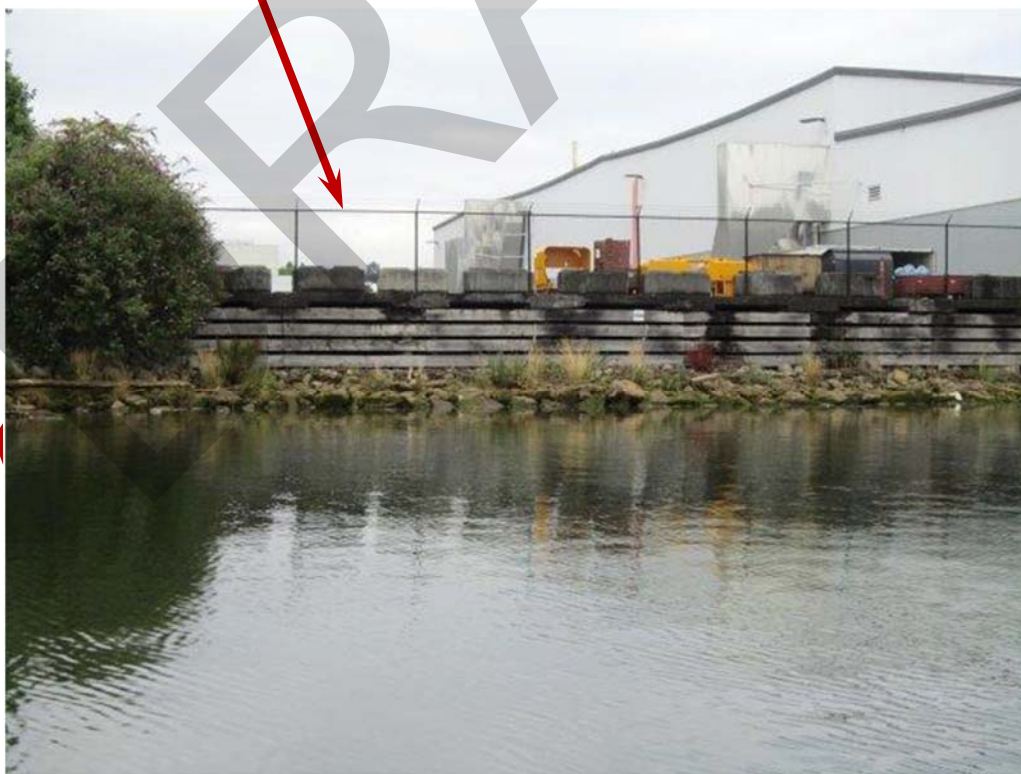
OF01-02: North End of Building

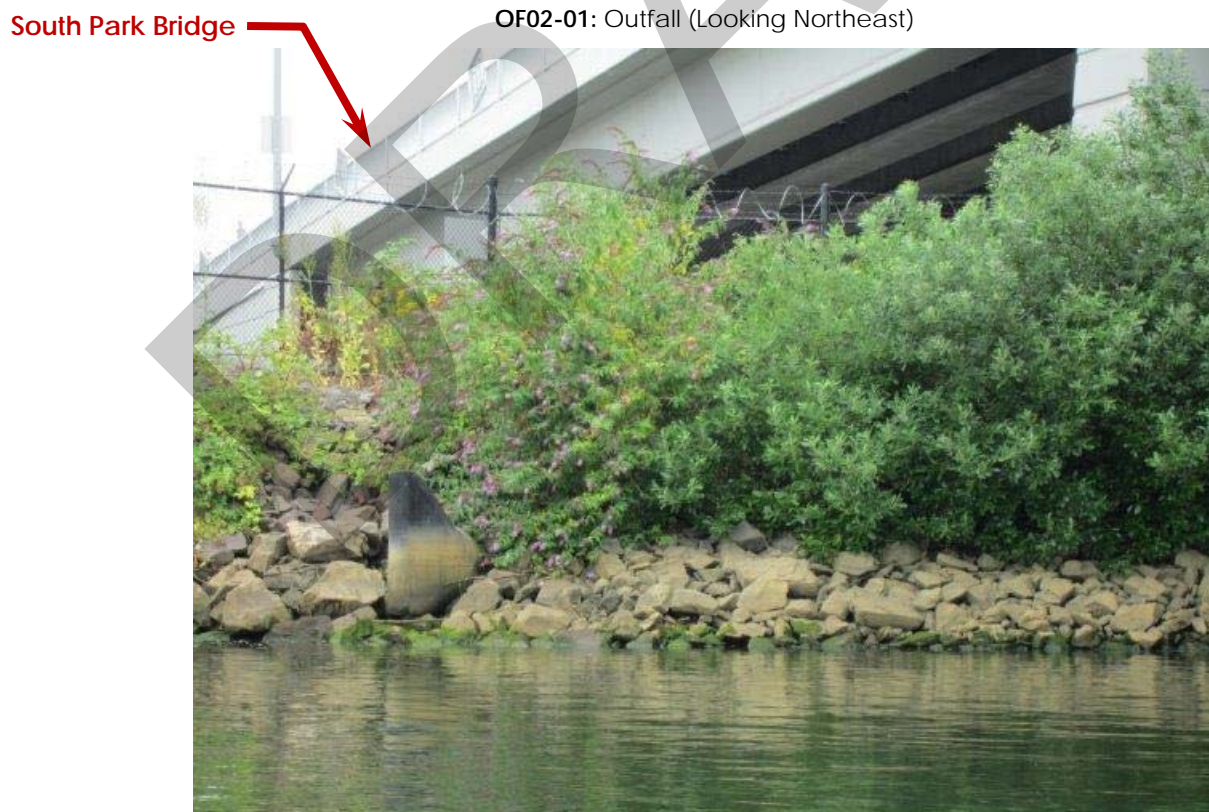
OF02-02: Outfall (Looking Northeast)
